ABBOTT MEMORIAL TRUST DAM

N H 00260

**PHASE I INSPECTION REPORT
NATIONAL DAM INSPECTION PROGRAM**

APRIL 1979

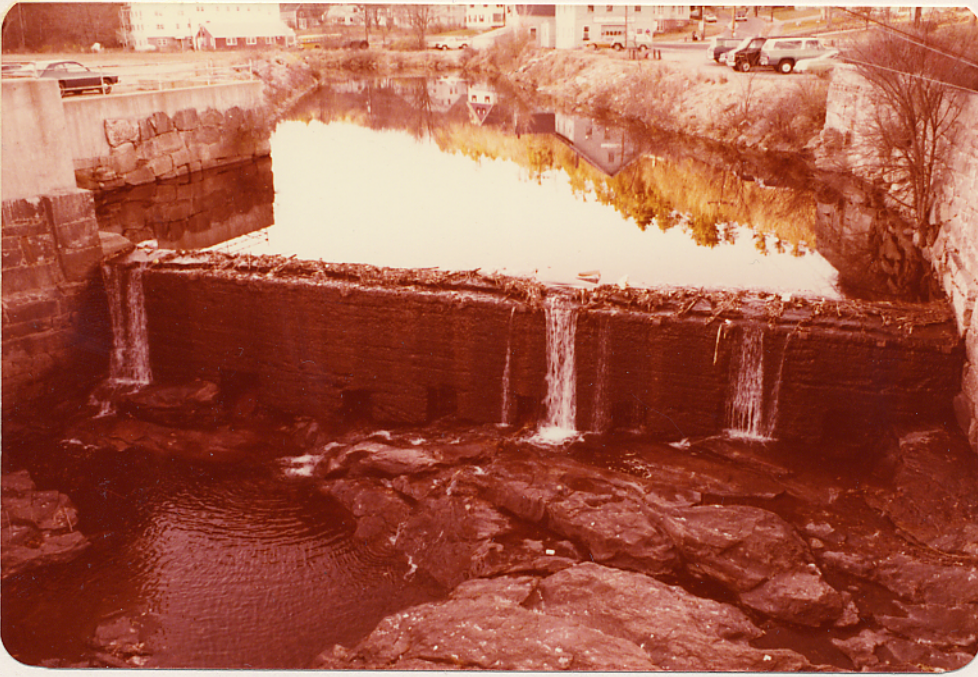
Overview from road bridge downstream of dam

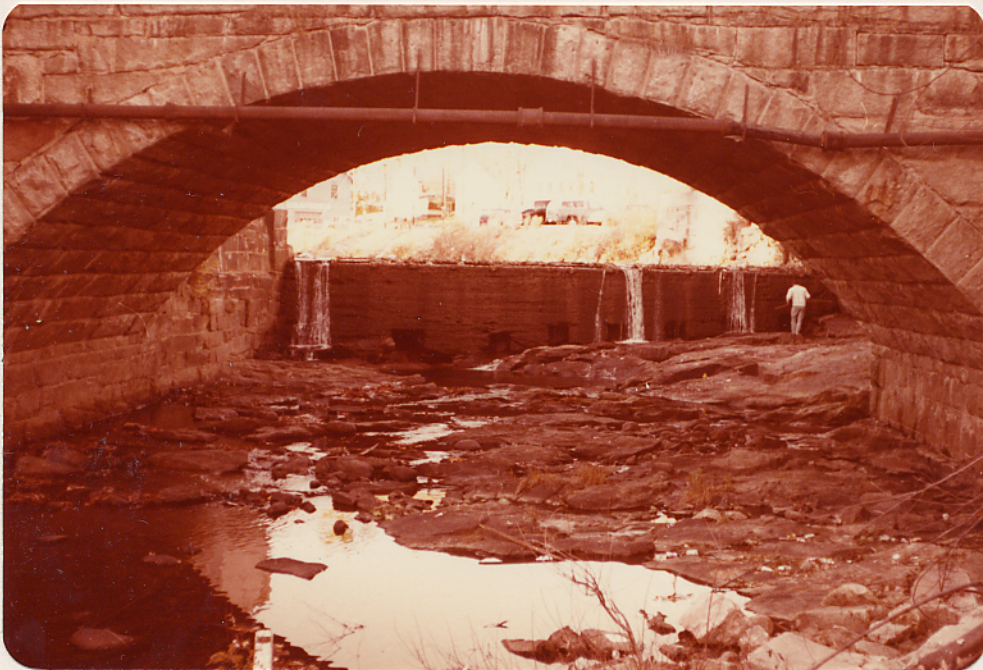
Overview from downstream channel showing
opening under road bridge

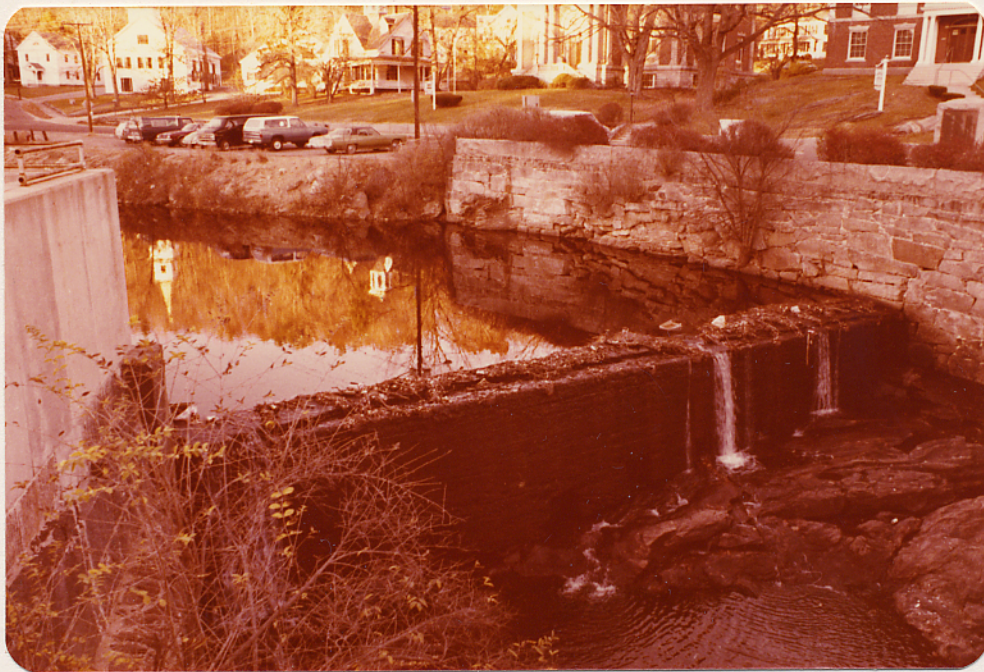
The upstream training wall (Photo 1) extending to the splayed portion of the wall has eroded joints to a height of 5 feet above its base and running for the length of the wall. The erosion is attributed to scouring and ice damage. A former opening, which has been sealed with cemented stone masonry, is located at the base of the wall approximately 22 feet upstream of the spillway. Approximately 10 feet further upstream another opening has been sealed with cemented stone masonry. There is

1. View from right side of road bridge showing bedrock outcrops at left abutment

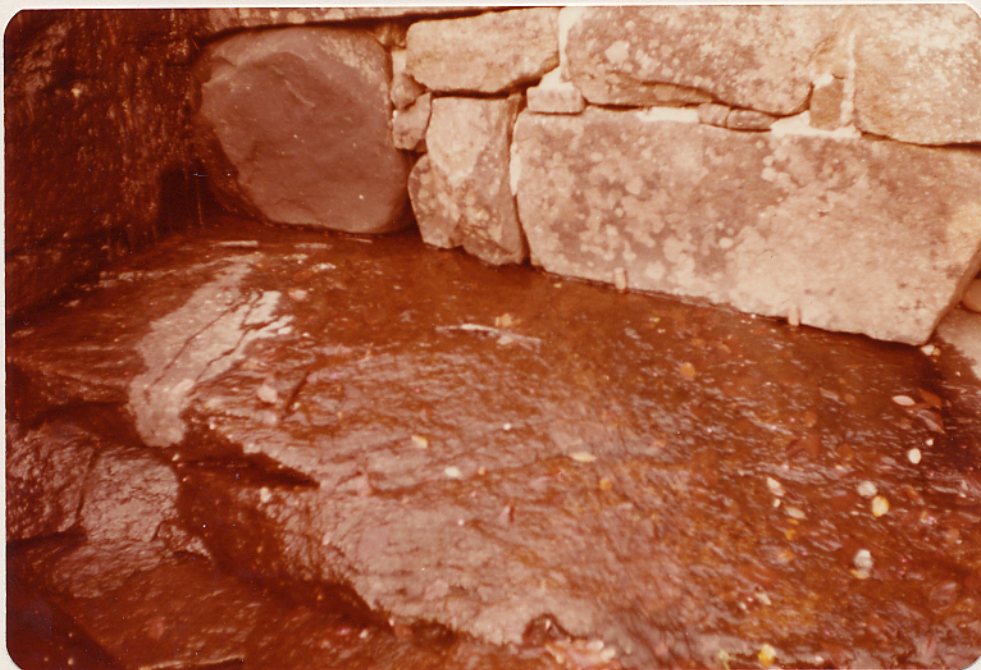
The stone masonry at the base of the downstream training wall has ravelled. The ravelling is located immediately downstream of the spillway, and a void approximately 5 feet long, 2 feet high, and 18 inches deep has resulted. Chinking stones have been displaced at the base of the wall for an additional 10 feet. The unravelling and displacements are attributed to scouring and ice damage. The joints of the lower 2 feet of the wall are completely void of mortar.

Seepage (Photo 2) of approximately 15 to 30 gpm was flowing through the interface of the stone and the rock foundation. Steel shear pins have been driven immediately downstream of the spillway to resist lateral movement of the base of the wall. Supplementary stone masonry was set in mortar in the vicinity of the downstream angle point in the wall. This masonry was placed in front of the original wall for approximately 15 feet. A prior failure had occurred at this location. Seepage at the rate of 2 to 4 gpm was flowing through a vertical joint between the downstream end of this wall and the bridge spandrel wall. The outlet for the seepage is approximately 1 foot below spillway crest elevation. Minor joint erosion was observed along the wall.

2. Detail of above showing seepage at junction with training wall and metal pins in bedrock to prevent displacement of base of training wall

- (1) Drain the impoundment pool to permit chinking and mortaring of all voids in the stone masonry and to seal the interfaces of the spillway at its ends.
- (2) Repair all voids at the downstream base of the spillway and the spillway crest.
- (3) Repair all deteriorated concrete at the dam.
- (4) Repair the rail fences on the right bank.
- (5) Remove vegetation from the face of the upstream training walls.
- (6) Institute a program of annual technical inspections.

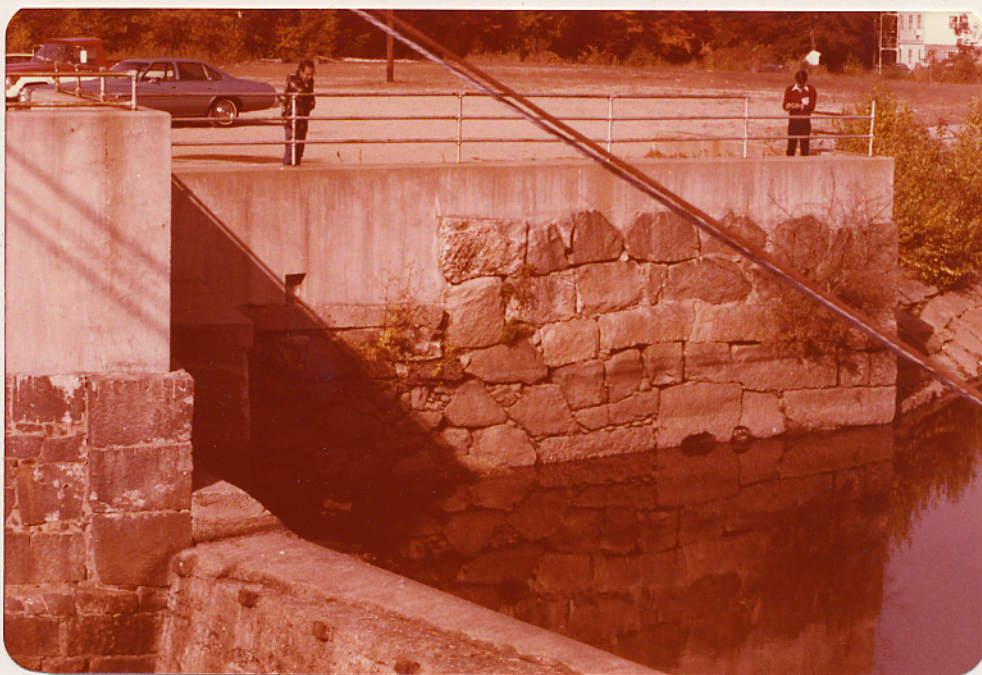
The upstream training wall and return wall (Photo 3) are constructed of dry stone masonry capped with a concrete wall of variable height. The top of the concrete wall is approximately 3 feet lower than the concrete walls at the end wall and downstream training walls. The stone masonry wall is in good condition with no evidence of spalls, cracks, or efflorescence. The upstream end of the pipe rail fence has missing rails.

3. View from left abutment showing right upstream training wall around site of old mill building

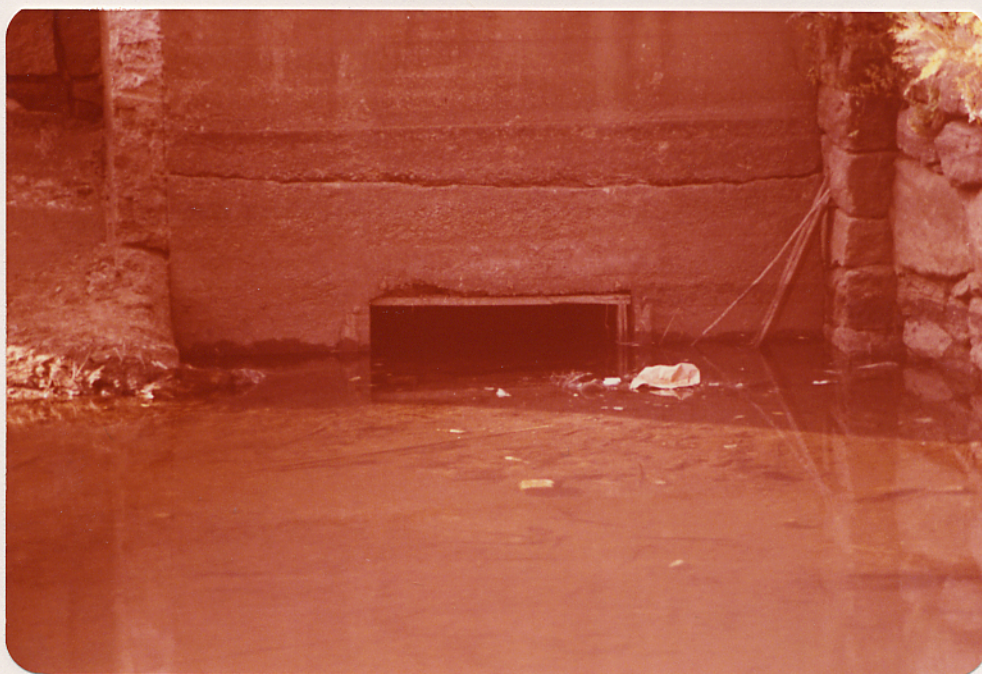
This structure (Photo 4) is probably a concrete-faced and capped structure which was included in the original dam construction. There was no sign of any operating equipment or sluice gate at the time of the inspection. The top of the structure is approximately 5 feet above crest level. The tailrace was partially demolished upstream of the roadway and rubble fill sealed the opening in the tunnel. At the time of inspection, seepage at the rate of 0.1 gpm or less was observed flowing at the tailrace outlet.

4. View from upstream of old sluiceway at right abutment which has been sealed with boulders

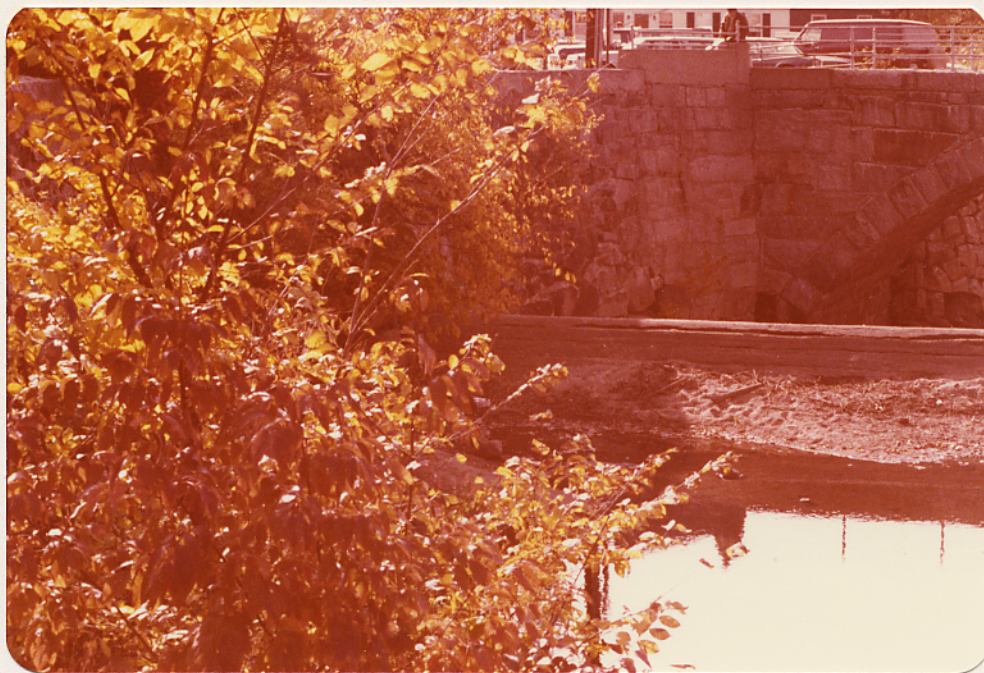
The top of the spillway (Photos 5 and 6) is capped with granolithic concrete. The cap is spalled over 50% of its surface area, and the spalling is up to 4 inches deep. Three full length construction joints on the upstream face have opened over the entire length of the spillway. The surface spalling and joint erosion is attributed to ice damage. Seepage was observed at the interface with both training walls.

Spalling of the spillway cap has occurred over 50% of the surface area. Several construction joints have also opened on the upstream face. Surface erosion at the downstream spillway base has occurred. Seepage was observed through the old sluice gate.

5. View of spillway from upstream showing horizontal cracks and soil deposition behind dam

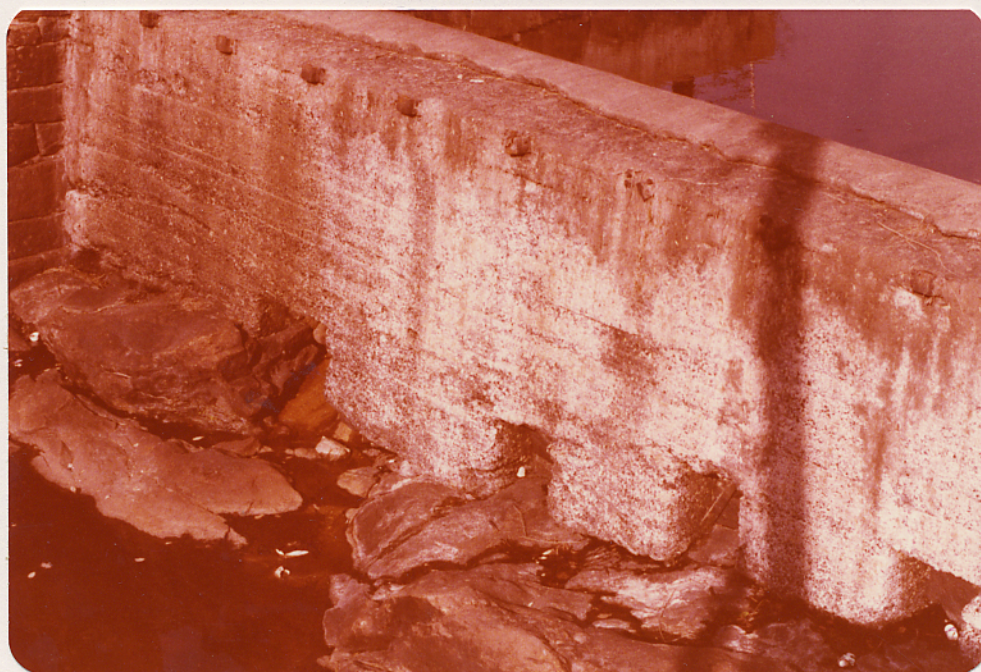
The 3.3 foot by 4 foot opening (Photo 6) is an outlet for a tunnel with an inclined metal sluice gate. The gate is set at a 1 horizontal to 1 vertical slope and is located approximately 15 feet upstream of the downstream spillway face. No operating equipment was observed. Seepage was observed flowing through the tunnel at a rate of 10 to 20 gpm. The remaining six square openings are pressure relief vents 15 inches deep and terminate at the face of the original stone masonry dam. Minor seepage was observed at these openings. Reinforcing steel is exposed and rusted at the tops of all seven openings.

6. View from left side downstream showing typical deterioration of spillway face, old sluiceway (larger opening), and pressure relief drains (smaller openings)
